LAKE-IN-THE-CLOUDS DAM

NDI ID NO. PA-00741
DER ID NO. 52-125

PHASE I INSPECTION REPORT
NATIONAL DAM INSPECTION PROGRAM

JUNE 1980

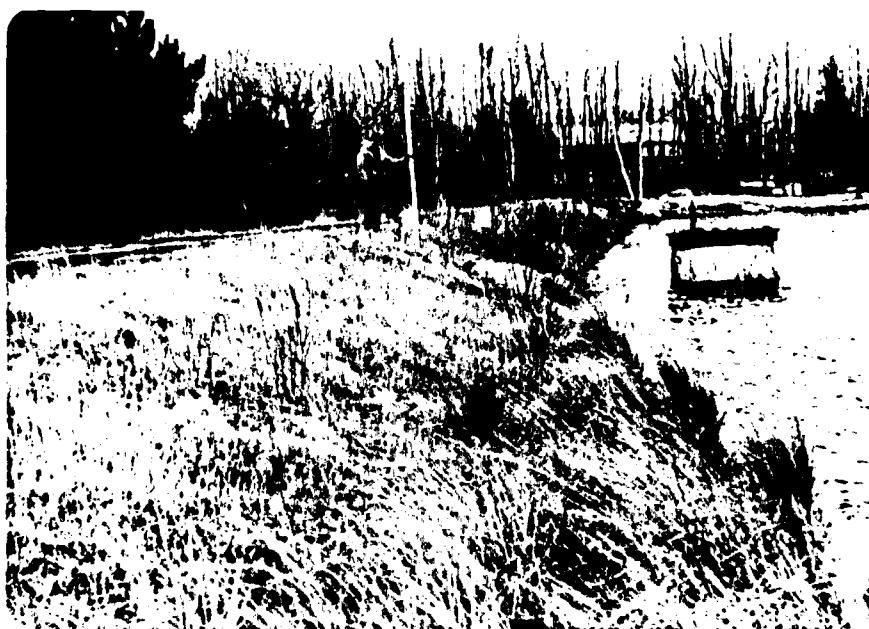
B. Upstream Slope

The erosion on the upstream slope is also minor at present. It is caused by a combination of surface runoff and wave action. The poorly graded riprap has probably worsened the situation. Further erosion is likely if remedial measures are not taken.

- (6) Design and construct erosion protection for the upstream slope of the embankment.
- (7) As part of the maintenance program recommended below, fill burrowing animal holes, cut brush on the upstream slope, and prevent unauthorized changes at the embankment.

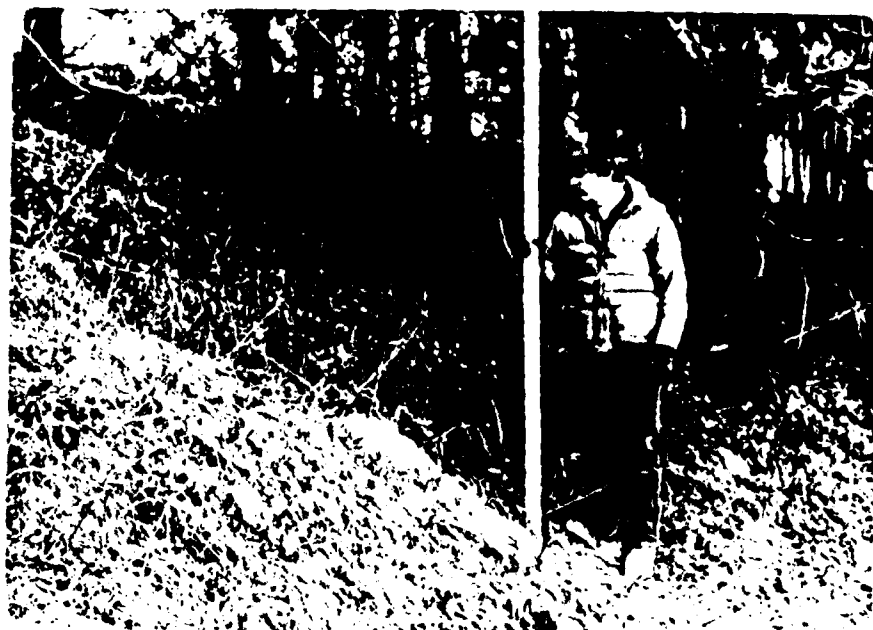
C. Downstream Slope

A relatively narrow path along the top of the dam is paved with asphalt. The downstream slope has many mature trees growing in it. The slope is very uneven, with many shallow holes, humps, and rills (Photographs C and D). A few burrowing animal holes were observed in the downstream slope. To the right of the spillway, a shallow 2-foot diameter hole has been excavated in the slope. A property owner who lives near the right abutment stated that he had just excavated the hole; he did not divulge the reason.

The cause of the lumps, holes, and rills on the downstream slope is not readily apparent. The condition could be caused by erosion before slope protection was established or by removal of tree stumps. As noted in Section 5, the dam may have been overtopped during Tropical Storm Diane in 1955; this would account for the condition of the downstream slope. The condition does not appear to be a stability problem.

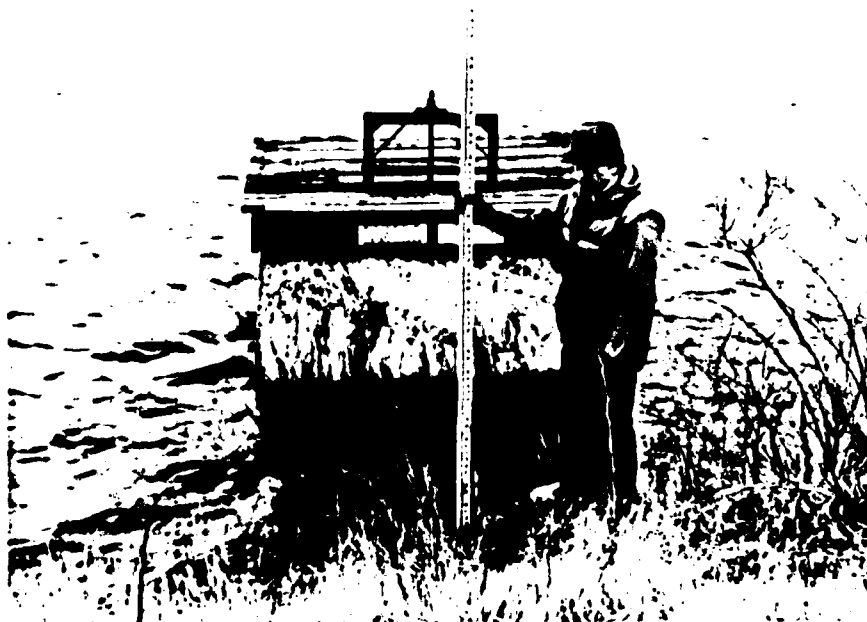
Fig. 1. Intake structure.

c. Appurtenant Structures. The concrete at the outlet works intake structure is badly spalled (Photograph E). The gate stem is badly rusted. No deficiencies were observed at the endwall, which was partially submerged (Photograph F). The streambed at the outfall is above the invert of the outlet works pipe (Photograph F). No representative of the Owner was present during the inspection, so the operation of the outlet works could not be observed. When subsequently contacted, the Owner stated that the outlet works had not been operated since he acquired the dam. He did not know where the operating mechanism was located; it is not on the intake structure (Photograph E).

(3) Appurtenant Structures. The spalled concrete on the outlet works intake structure appears to be severe. The structure is in the reservoir and access to it could not be obtained during the visual inspection. The spalling is probably caused by long-term exposure to the weather.

(5) Design and construct repairs for the spalled concrete at the spillway approach walls and outlet works intake structure.

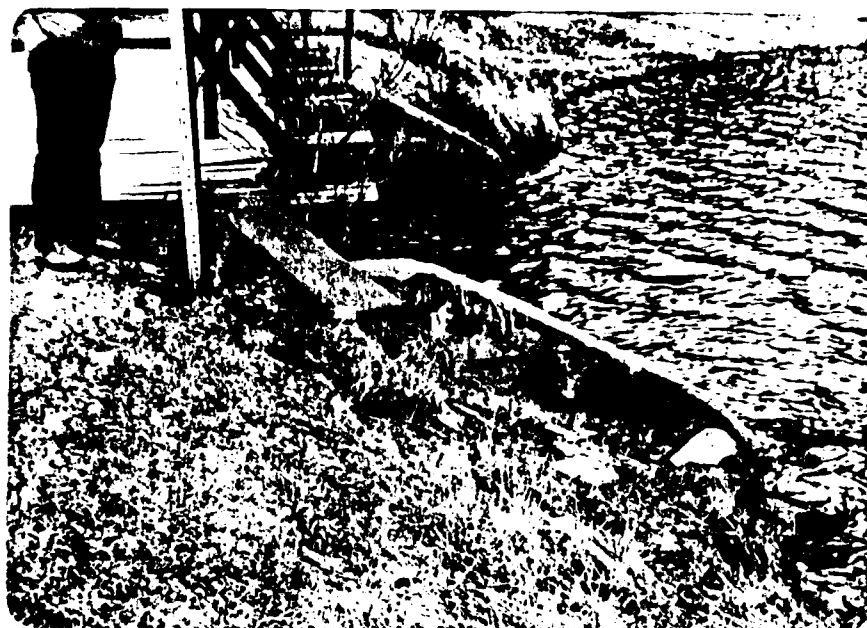
G. Spillway Approach

Stoplogs are provided in the middle of the spillway weir. The upper stoplog protrudes above the top of the weir (Photograph H). The approach walls are badly spalled. The concrete at the upstream end crumbles to the touch. The downstream walls have pattern cracks, leaching and minor peeling and spalling. The spillway bridge, which is fenced shut at the right end, is in good condition.

The conditions at the spillway walls downstream of the weir indicate that maintenance repairs may be necessary in the future. They are not sufficiently serious to warrant repairs at present. However, it is uncertain that the upstream end of the approach walls could sustain the imposed loads if any further deterioration were to occur.

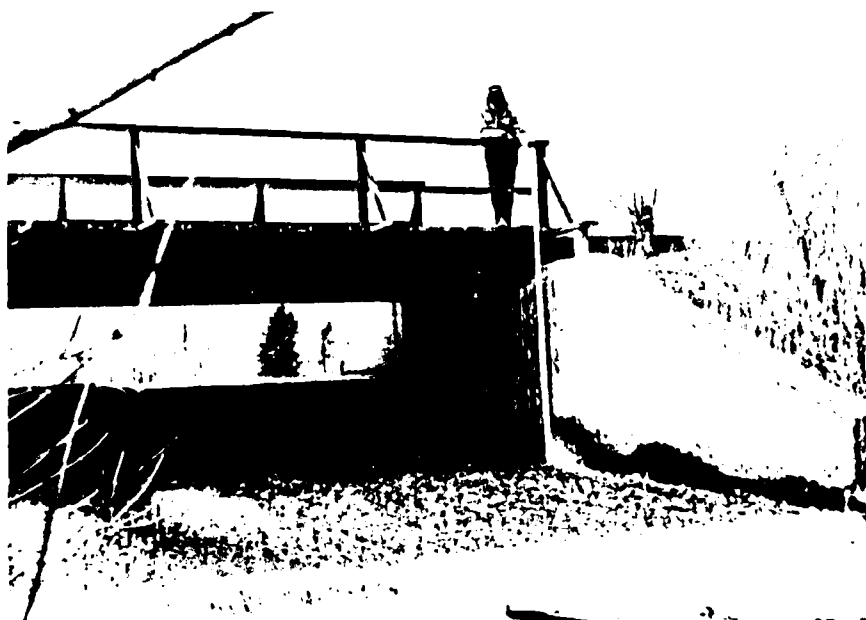
H. Spillway

The stoplogs in the spillway weir change the shape of the crest along the length of the notch. They also protrude slightly above the crest. Both these conditions reduce the spillway capacity slightly. However, their effects have not been included in the analysis described hereafter. The effects of possible pressure flow beneath the bridge have been included. The underside of the bridge also has the potential to collect debris; debris would reduce the spillway capacity. Its effects have not been included in determining the spillway capacity.
